21. Sector – Arankina Ada (km 1,247-1,244.8)

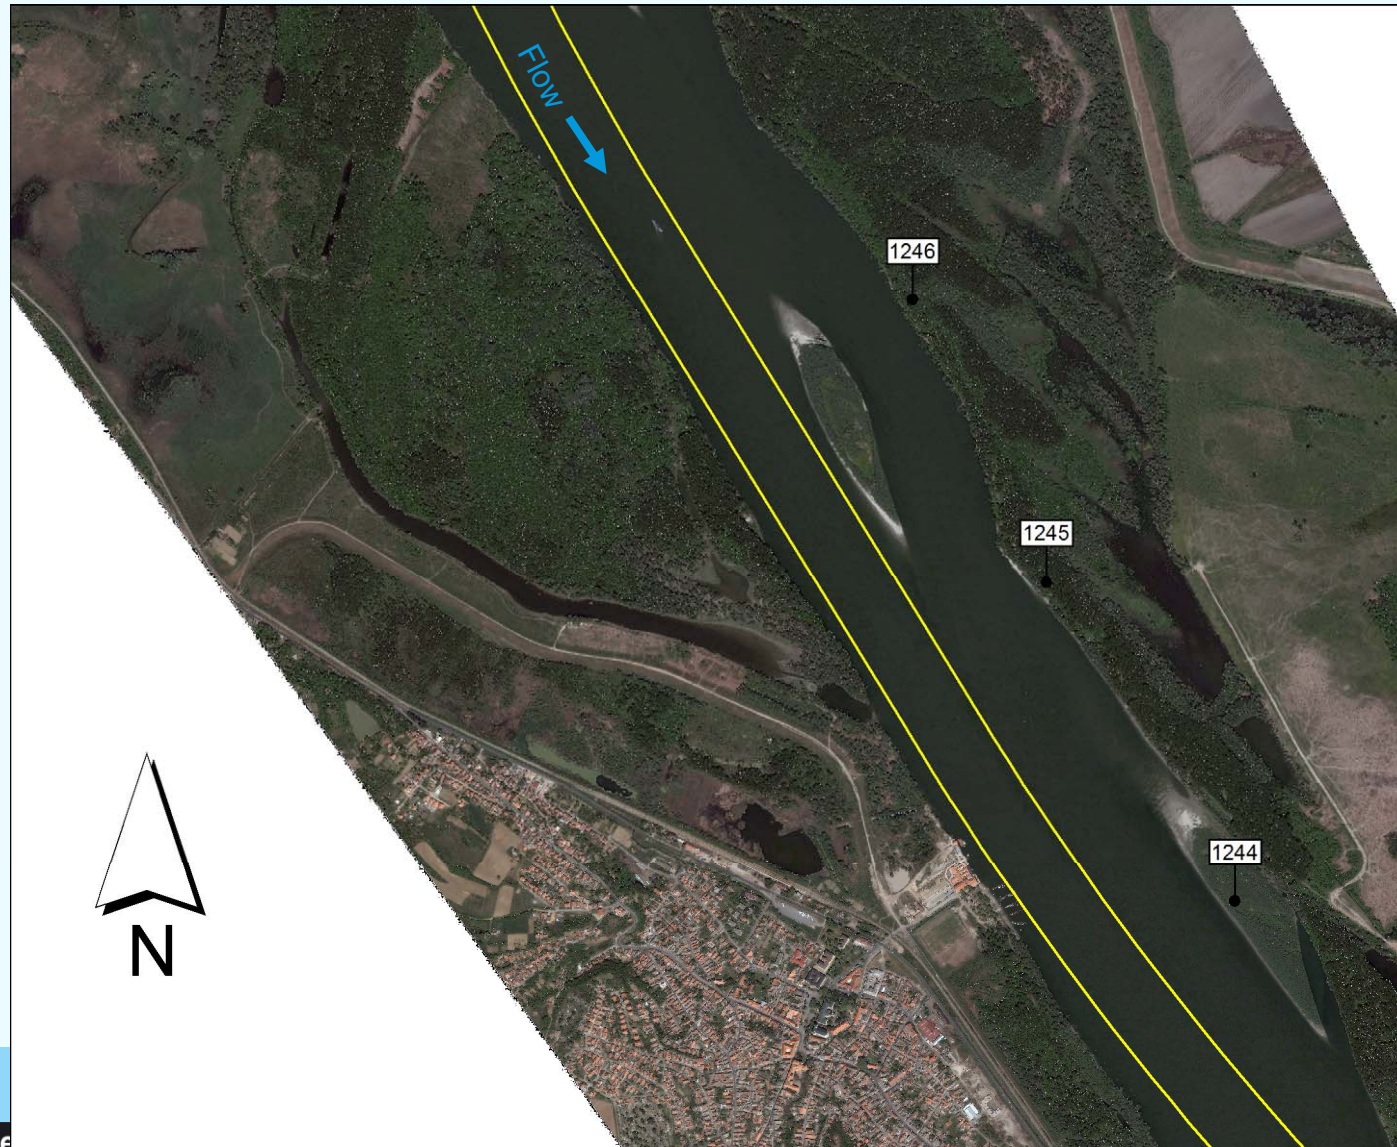
21. Arankina Ada – Existing situation

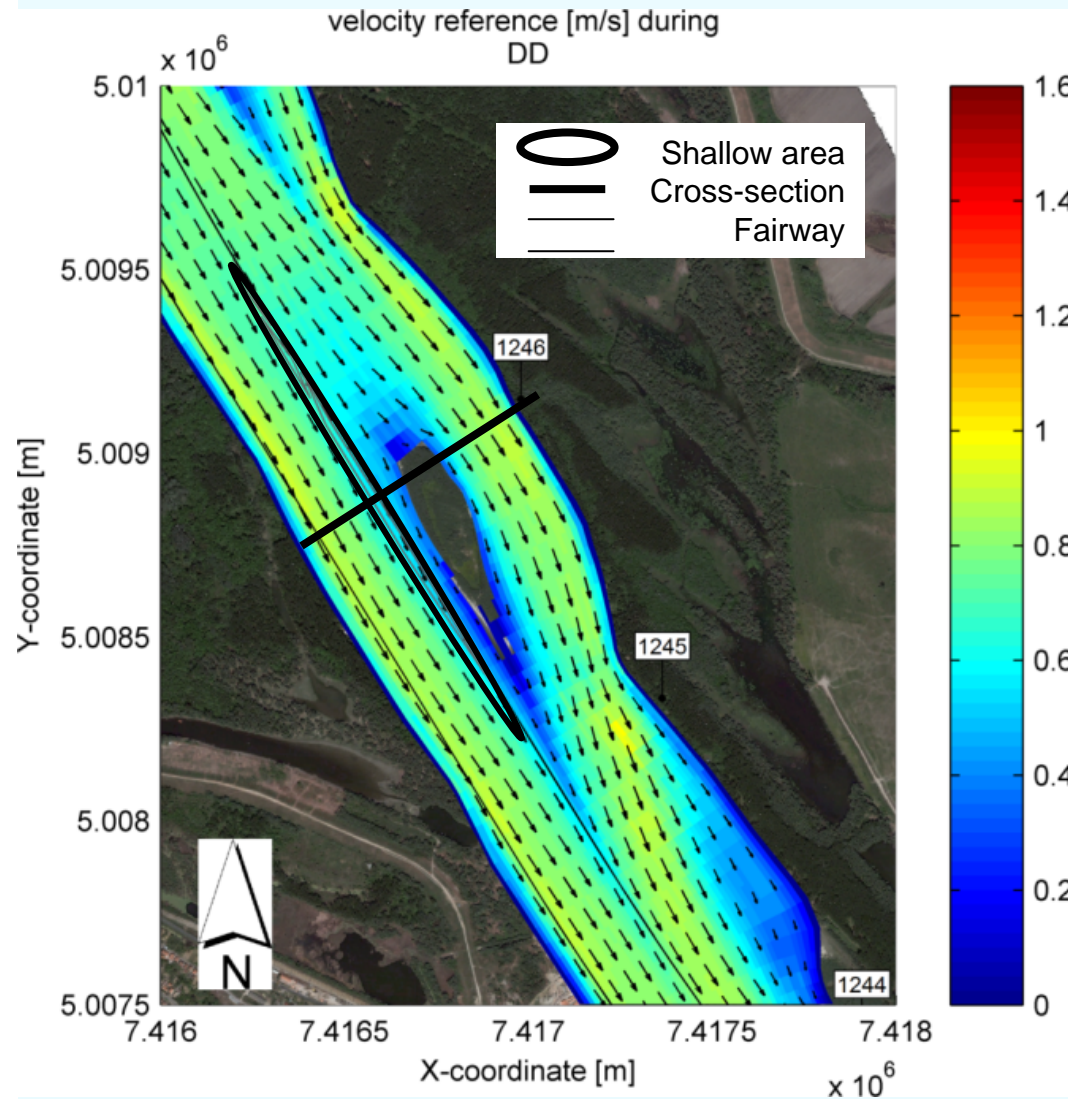
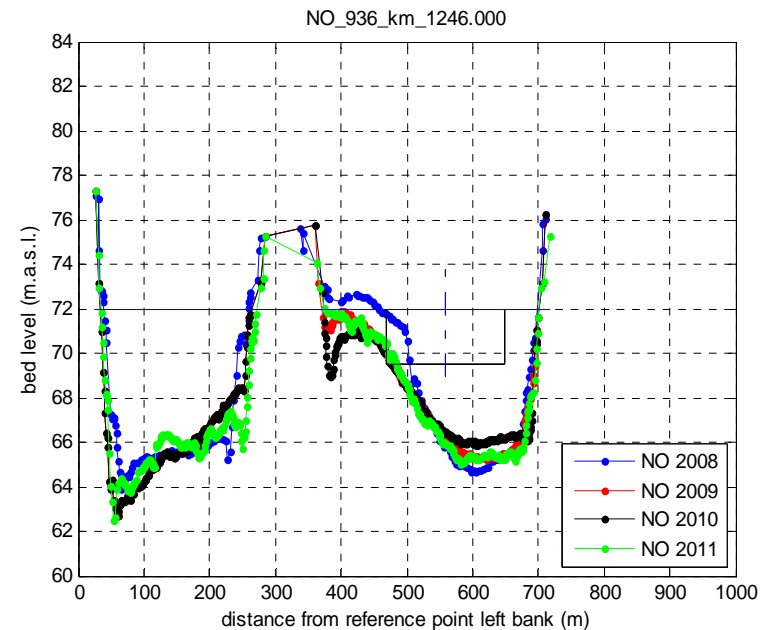
21. Arankina Ada - Existing situation

Navigation problems:

- Island protrudes into fairway along left side of fairway;

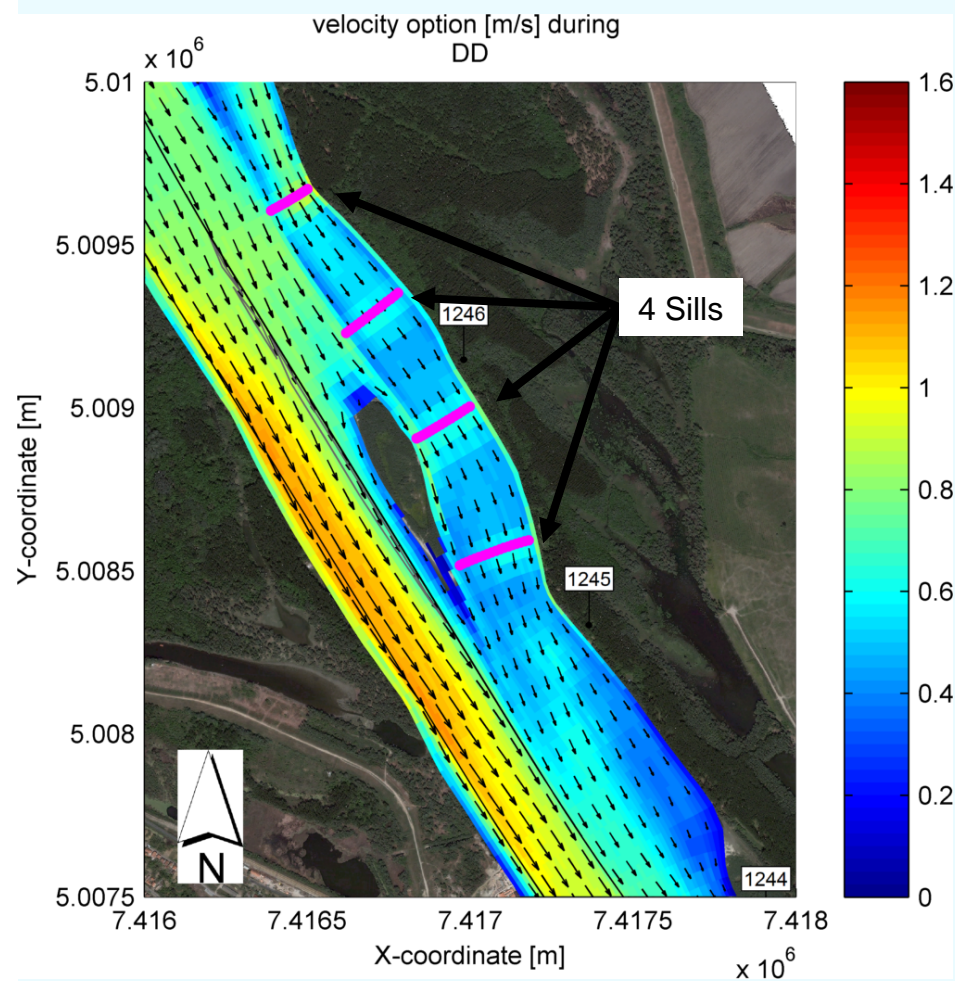
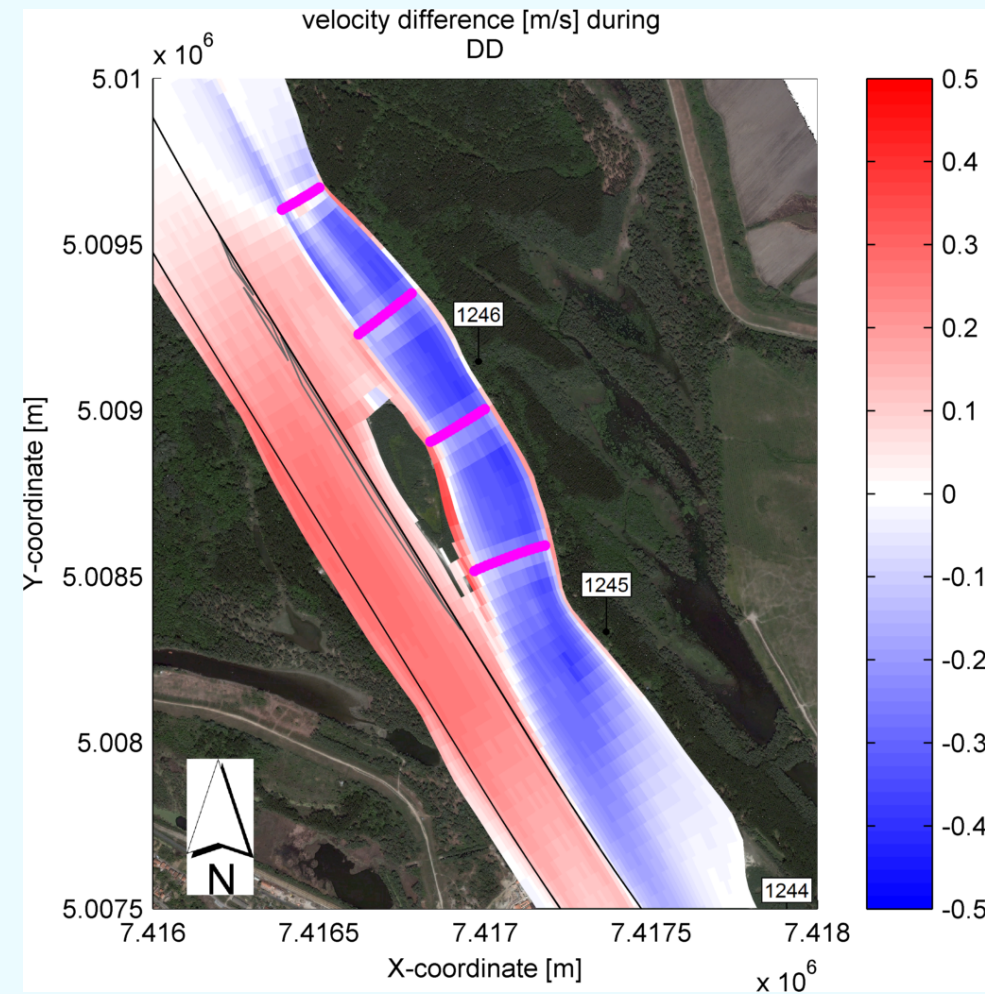
21. Arankina Ada: option 1: Sills

21. Arankina Ada – options 1 and 3

- Navigation:
 - increased flow in the fairway channel;
 - Option 3: additional dredging is required
- Environment:
 - Minimize erosion along right side island;
- Cost:
 - sills are about 150 m-200 m wide and 3 – 4 m high;
- Optimization of:
 - Sill crest level;
 - Exact location of structures.

Options	Effectiveness	Environment	Cost
Option 1 – sills	Effective	Minimal negative (+ some positive) impact	Limited
Option 3 – two chevrons + sill	Limited	Minimal negative (+ some positive) impact	Limited

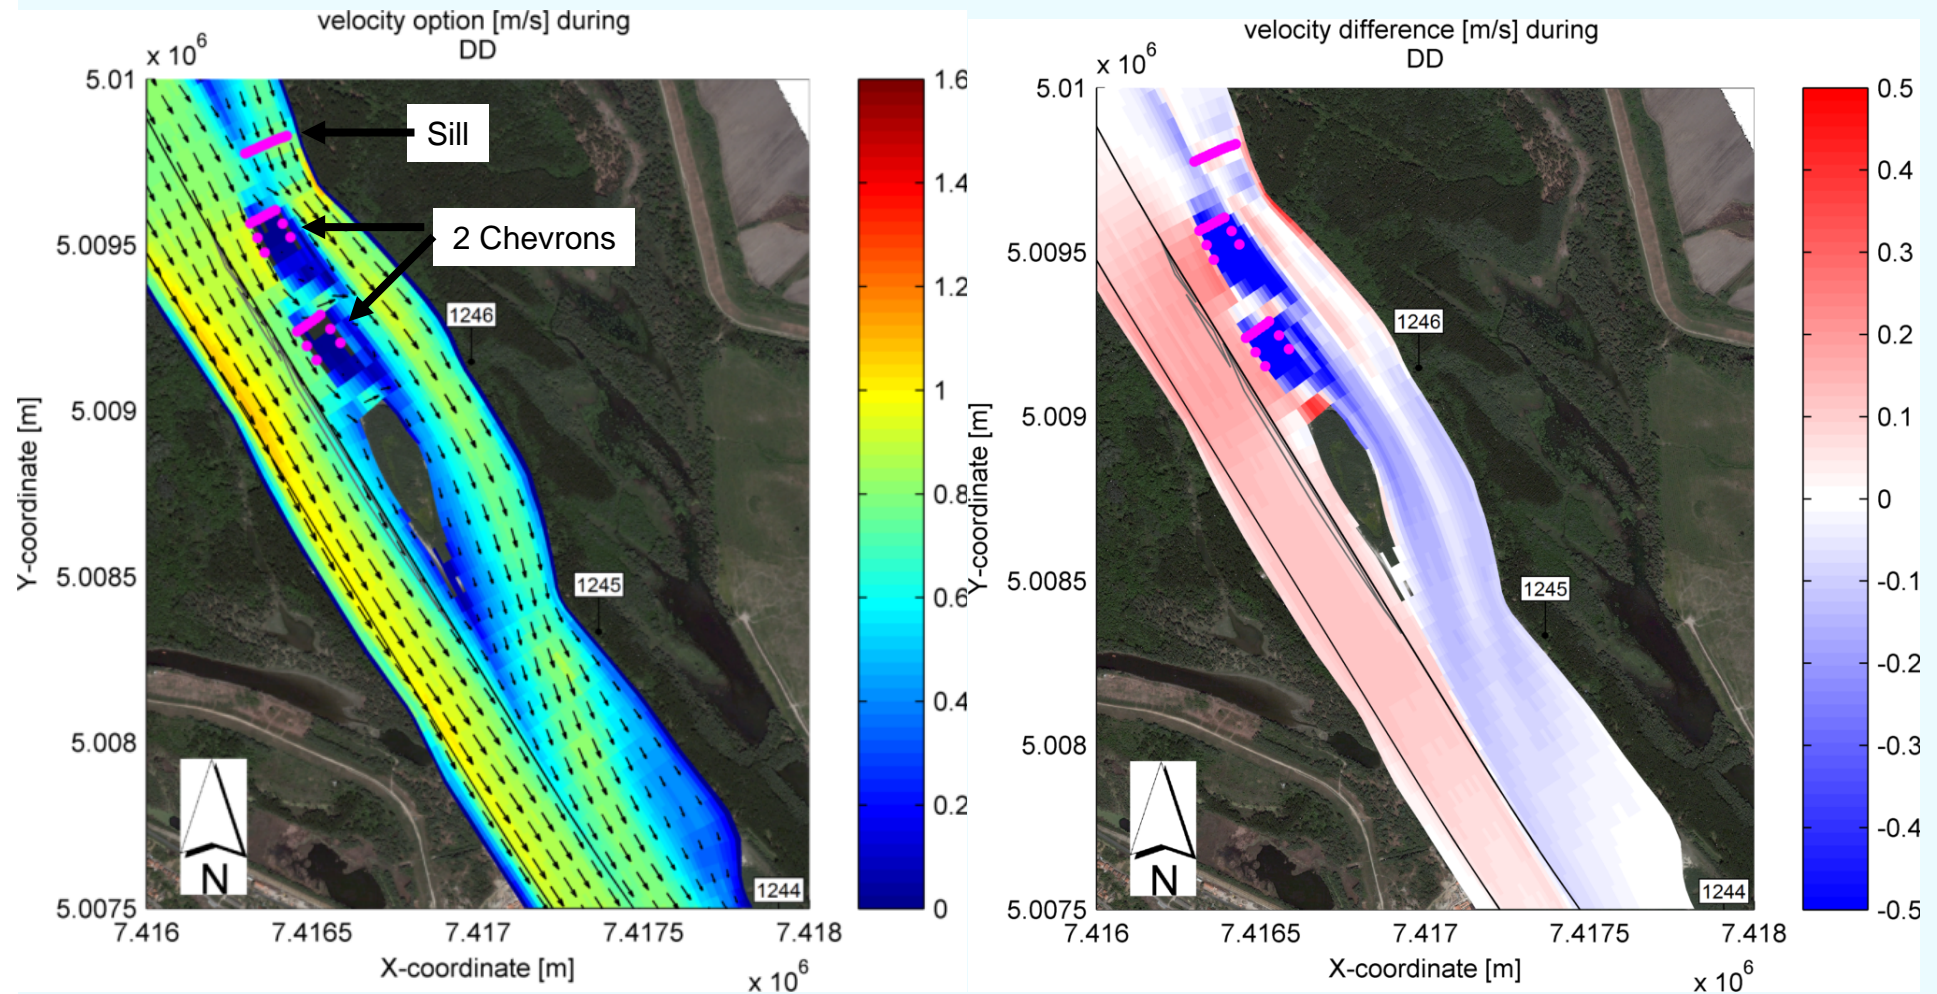
21. Arankina Ada – option 3: chevrons+sill
