22. Sector – Cortanovci (km 1,241.6 – 1,235.0)

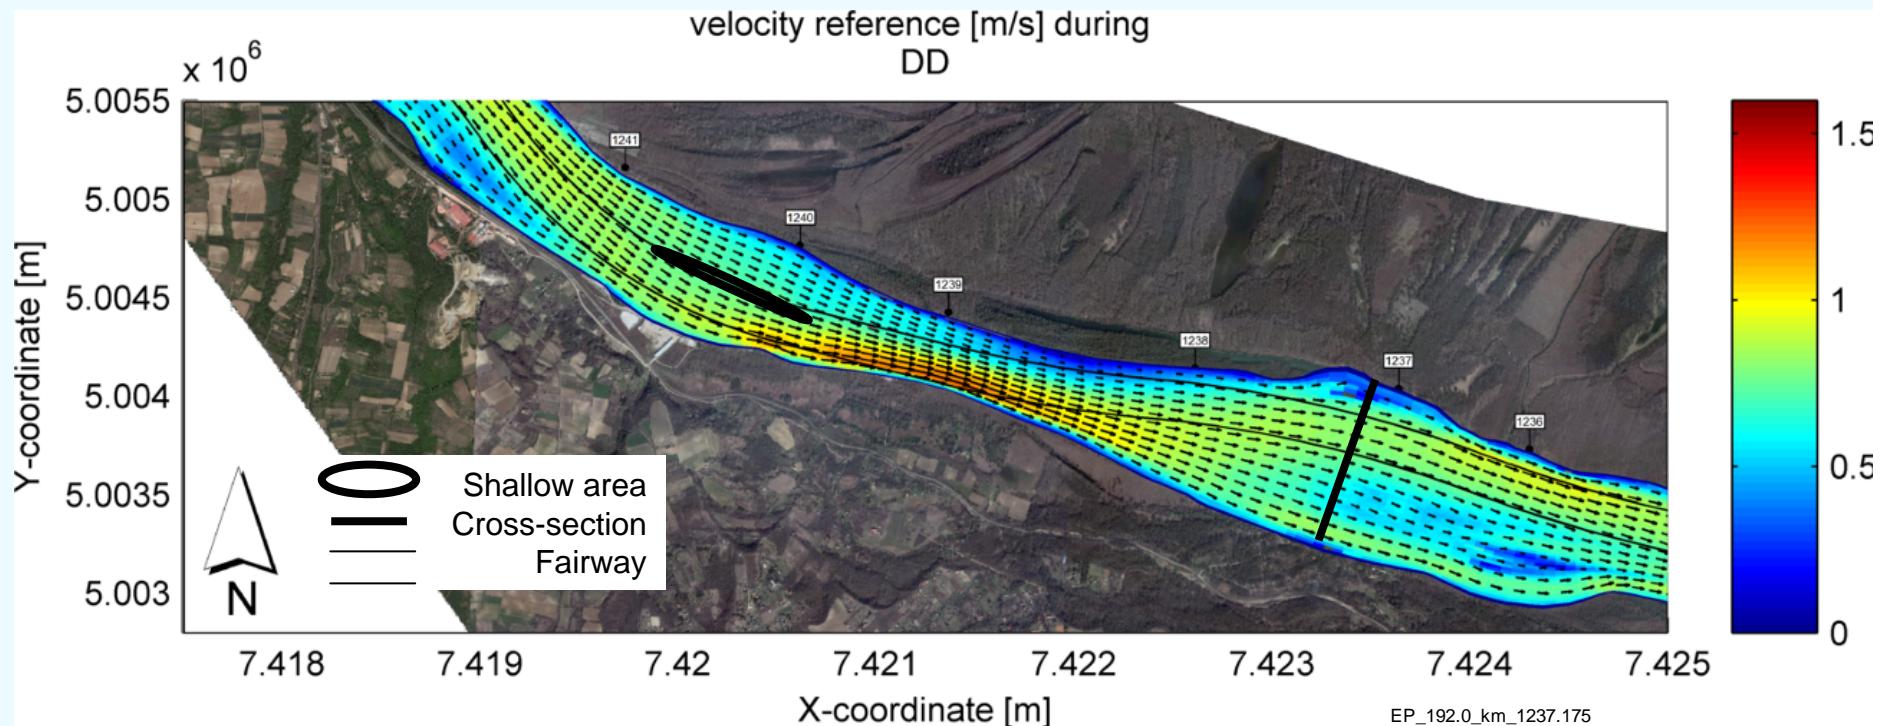
22. Cortanovci – Existing situation

Navigation problems:

- Upstream: narrow fairway in the bend due to point bar
- Downstream: unstable river bed

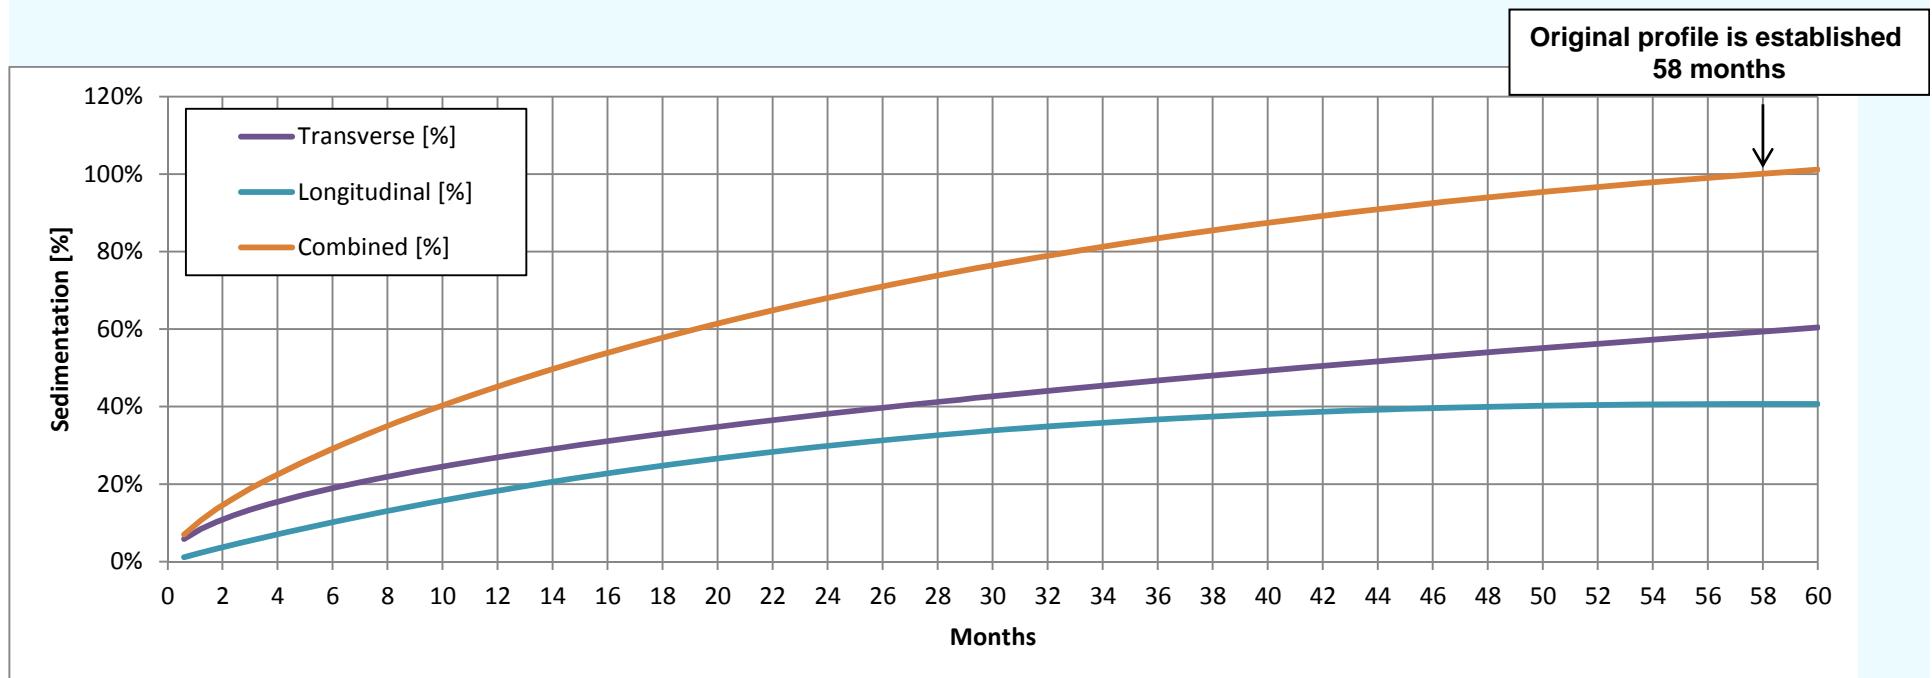
22. Cortanovci – option 2: Dredging

- Km 1239.4-1240.4 : 68,901 m³

22. Cortanovci – options 1, 2 and 4

- Navigation:
 - increased flow in the fairway channel;
 - additional dredging is required.
- Environment:
 - Upstream small part of point bar is eroded;
 - Preserved river dynamics in the sector.
- Cost:
 - Upstream: sills are about 50-100 m wide and 3 m high;
 - Downstream: sills are 70 m and 150 m wide and 2 m high
- Optimization of:
 - Sill crest level;
 - Exact location of structures.
