23. Sector – Beska (km 1,232.0 – 1,226.6)

23. Beska – existing situation

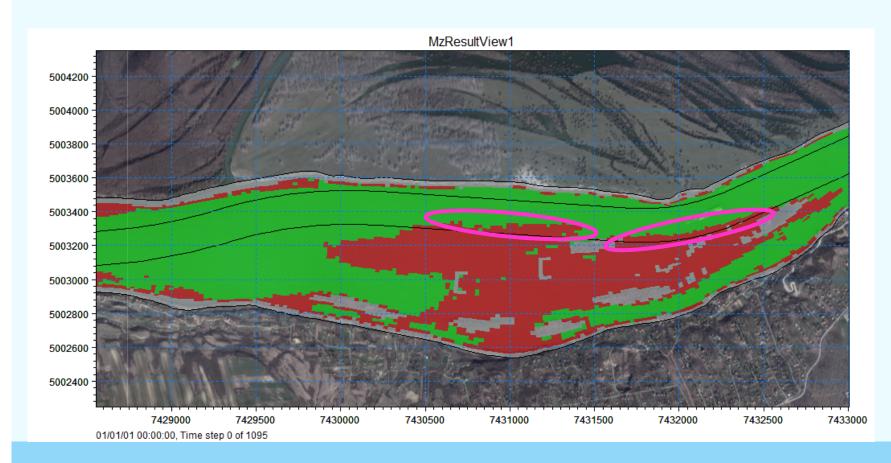
23. Beska – existing situation

Where is the depth less than 2.5 at DLNL (2012)?

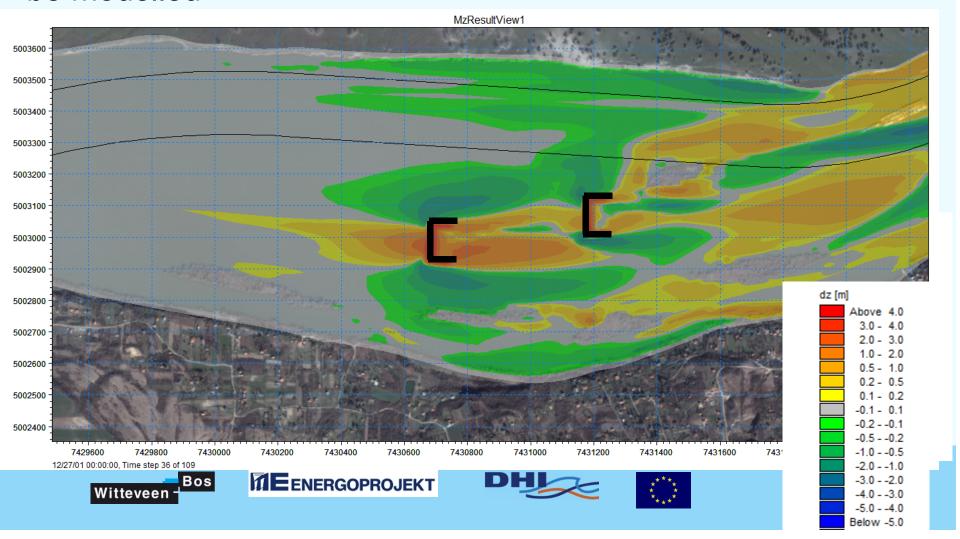
23. Beska - simulation

Simulated bed level changes after 1 year, remaining 2 years to be modelled
